**Bridge Name:** Robert J. Adams Bridge  
**Road Carried:** River North Drive  
**Over:** Ocmulgee River  
**Location:** Bibb County, Georgia

Inspection Date: July 26, 2023

Report Date: July 27, 2023

Gresham Smith  
1125 Sanctuary Parkway, Suite 350  
Alpharetta, GA 30009

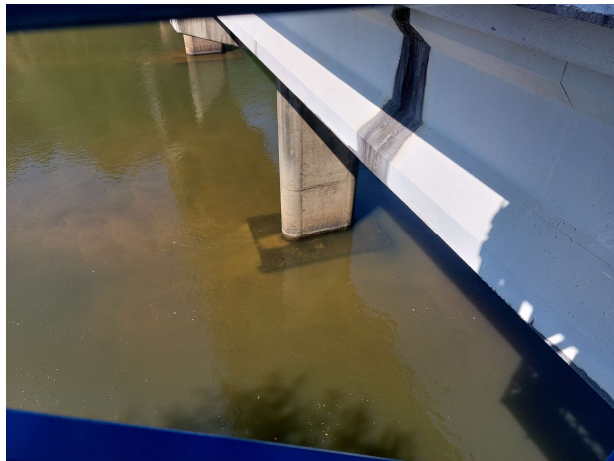
Bent 4 Footing

**Footings:** The tops and a small portion of the sides of the footings at Bents 3 and 4 are visible, but silt has covered the seals and seal repairs. This was noted from the under-bridge vehicle platform as no underwater inspection was performed.

Silt around footing covers seal

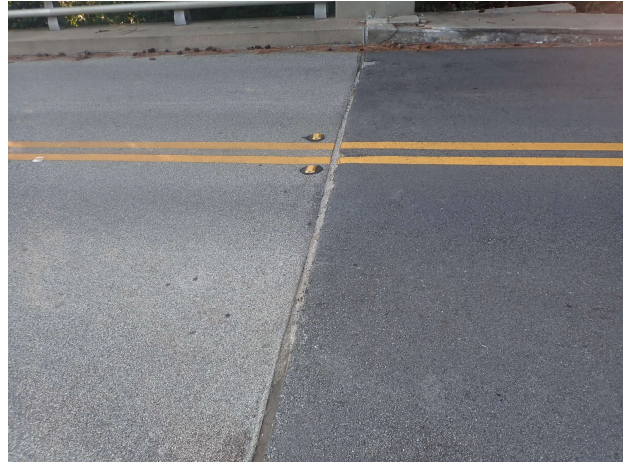
Bent 1 Joint

Joint intact, copolymer overlay intact

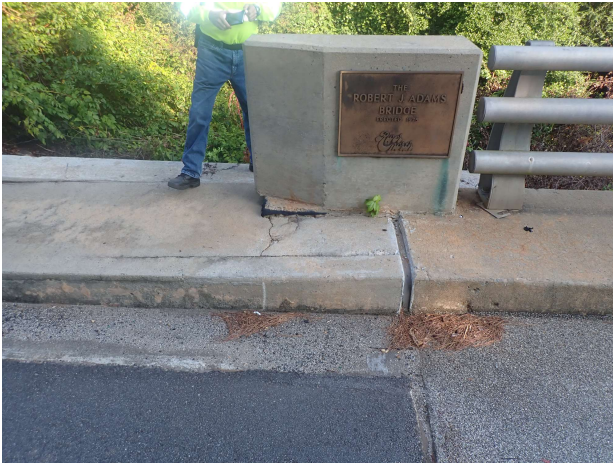
Bent 1 Left End Post

Cracking in sidewalk approach just before entering bridge.

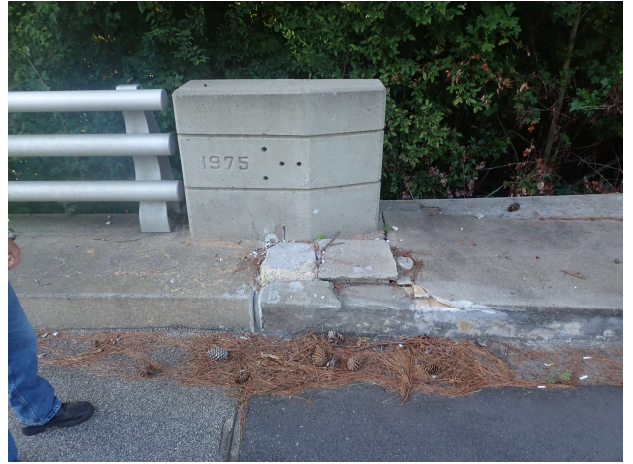
Bent 1 Right End Post

The sidewalk (curb) slab on the right and left side of the southwest end of the bridge has some minor cracking. At Bent 1 (the rear abutment) on the right side, the beginning of the sidewalk has cracked and heaved upward slightly. This could be a trip hazard to pedestrians. The standard three (3) rail aluminum handrail is in good condition with no vehicle collision damage or settlement. Several minor dents still exist from the 1994 flooding. The overhangs are in good condition with some minor deterioration. Typical concrete cracks exist throughout the sidewalk (curb) up to 0.02”. There are Barn Swallow nests present in the overhang. The metal deck forms between the beams show signs of minor rust.

Sidewalk damage just before entering bridge creates a trip hazard.

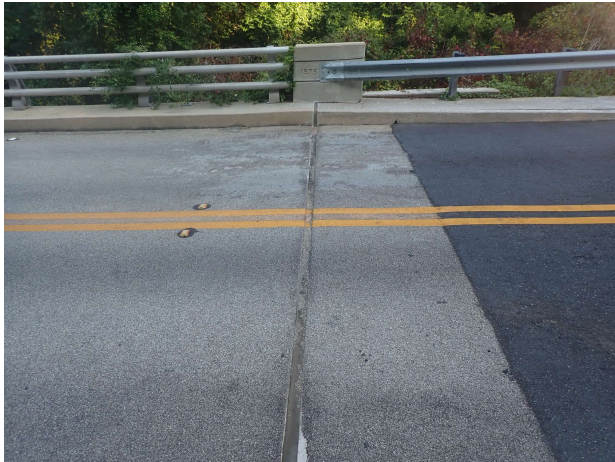
Bent 6 Joint

Joint beginning to leak, Overlay has some damage around joint in far lane.

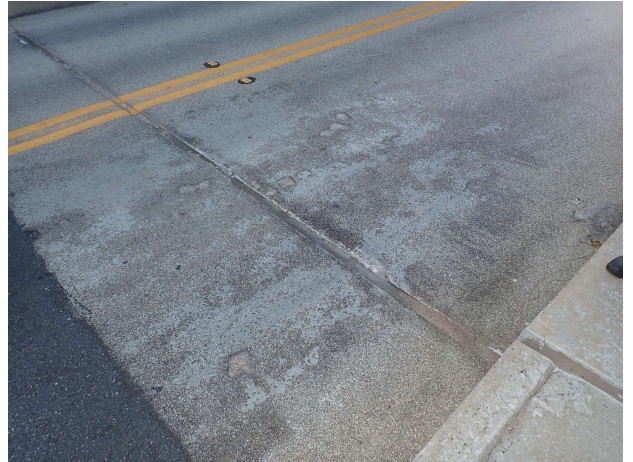
Overlay Damage

Area of damage in overlay 7' X 11'. Damage is on approach slab and beginning of bridge. Has worn down to concrete.

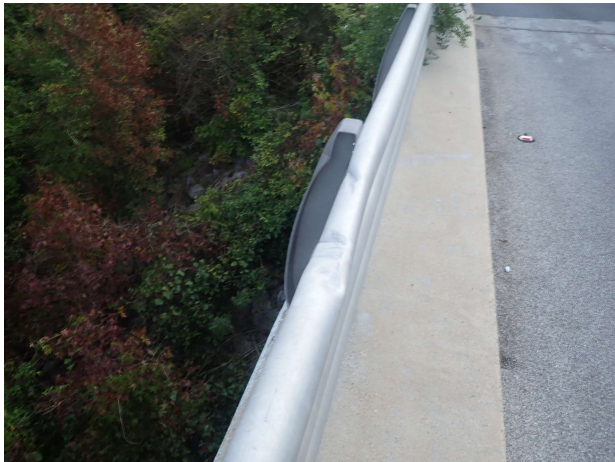
Handrail damage

Damage from debris impact from 1994 flood

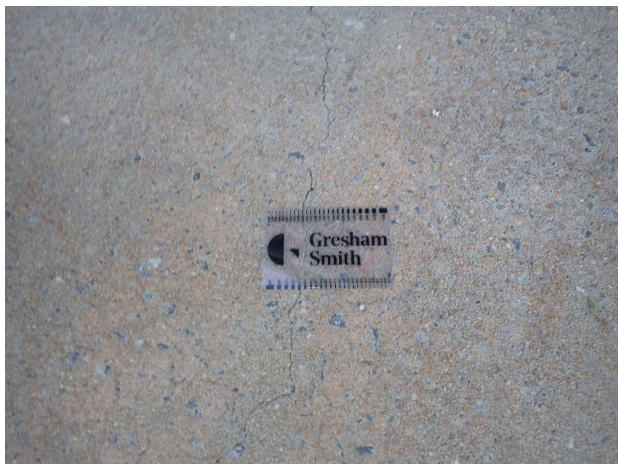
Crack in Curb

Crack in curb in Span 4 up to 0.02". Typical concrete cracking.

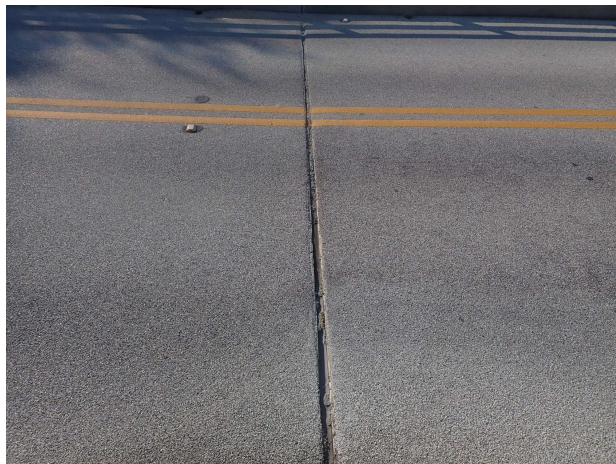
Bent 4 Joint

Joint is beginning to leak.

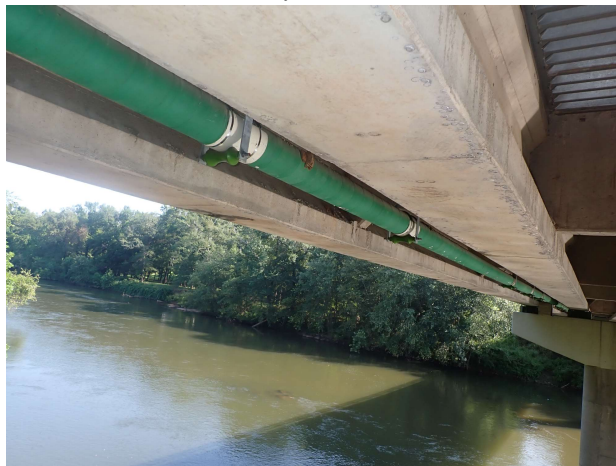
Utility, Gas Line

Gas line is suspended between Beams 1 and 2.  
Looking toward Bent 3 rear.

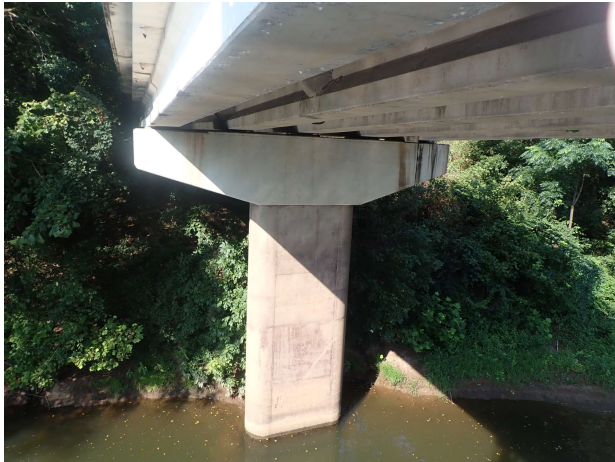
Bent 2 Forward

Stains on cap are an indication of joint leakage.

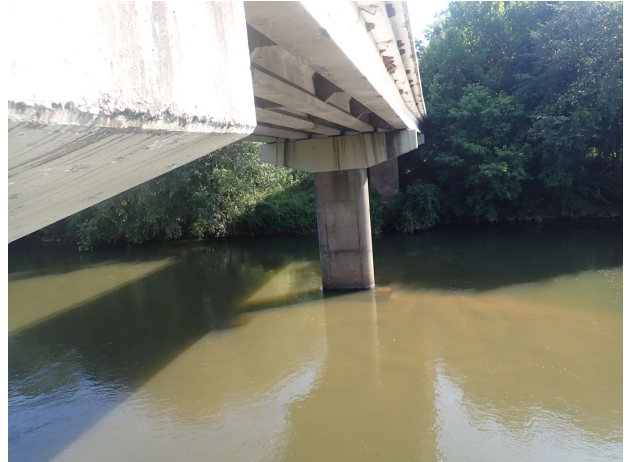
Bent 4, Rear

Staining on Cap is from leaking joint.

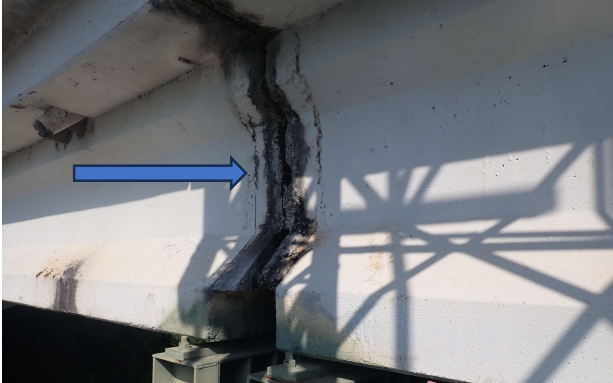
Cracking at Edge Beam

Bents 3 through Bent 5 have cracking at Edge Beams. This is not structural damage.

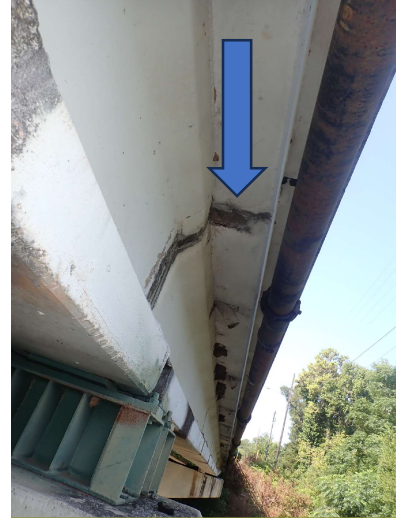
Bent 3

Small spall on overhang in Span 2.

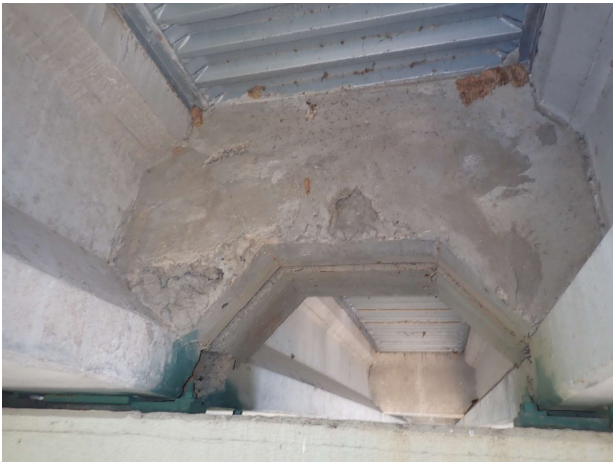
Bent 4, Span 3, Bay 2 – Edge Beam

Previous repair work to poorly formed edge beam. Repair is adequate, no further work needs to be done.

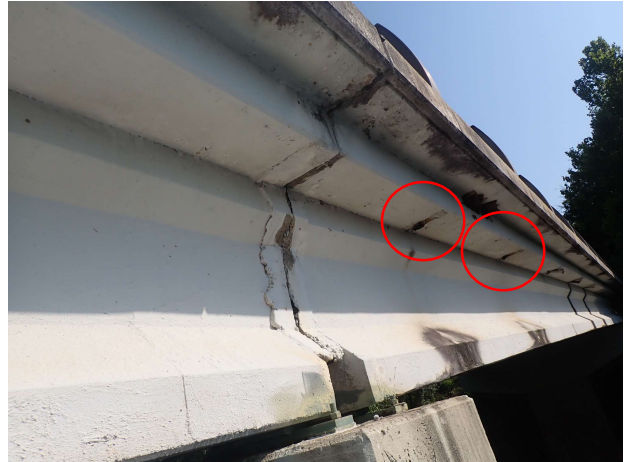
Bent 4 Right Overhang

Note broken scuppers and water stains on beams below them.

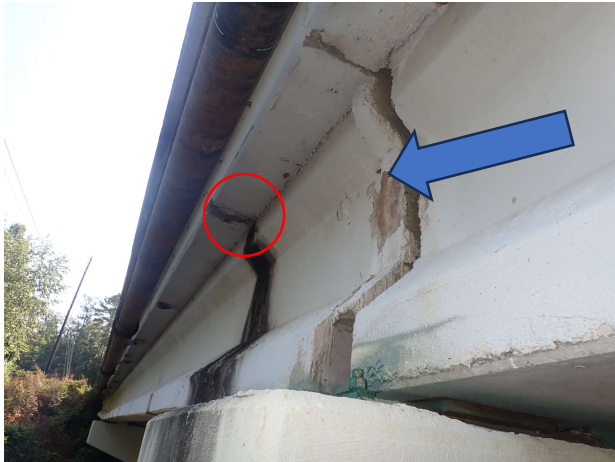
Bent 4 Left Overhang

Note broken scupper and water staining on beam.  
Edge beam poorly formed at construction.

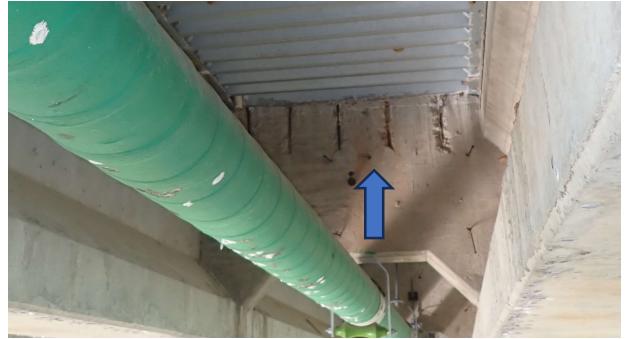
Diaphragm in Span 3 Forward, Bay 1

Spalling has exposed rebar due to shallow cover at construction. Should be cleaned and coated with epoxy to prevent further rusting and section loss.

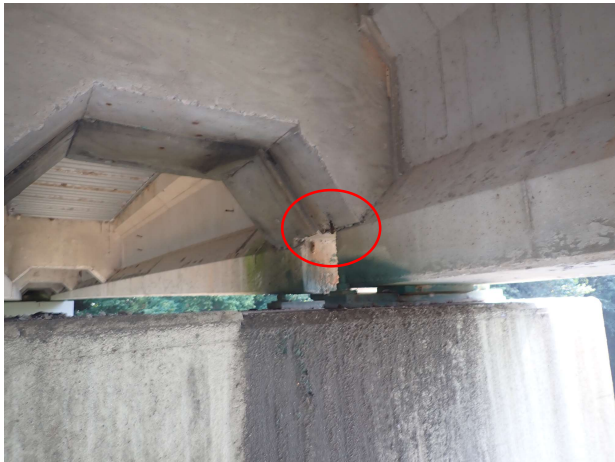
Edge Beam in Span 3, Bent 4, Bay 4

Small amount of rebar is exposed. This should be repaired when the repair is made at the Span 3 Diaphragm exposed rebar.

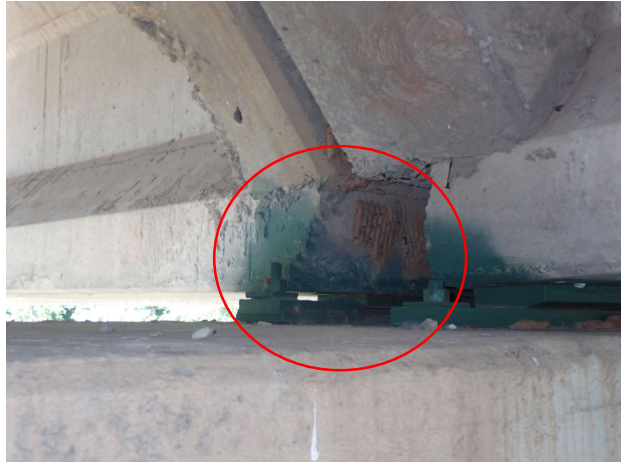
Beam 2 Span 3 corner spall

Small spall at the corner of Beam 2. No repair necessary.

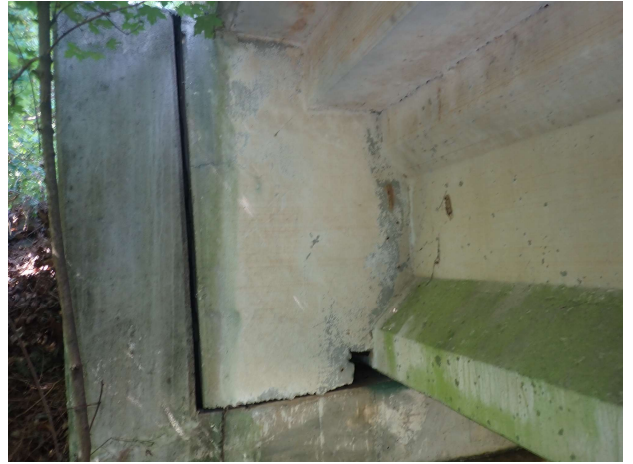
Bent 1 End Wall

It is difficult to see in photo, but end wall has minor cracking that is typical of concrete. No repair necessary.

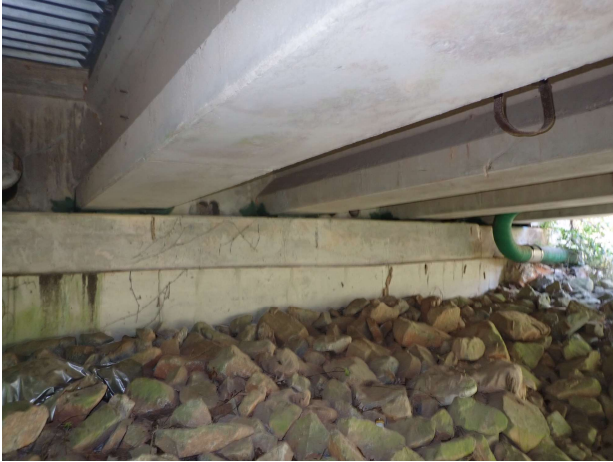
Bent 1 Forward, Left side

Concrete was formed and pumped to cover exposed piles in the past. Repair is in good condition. Rip rap protection is in good condition.

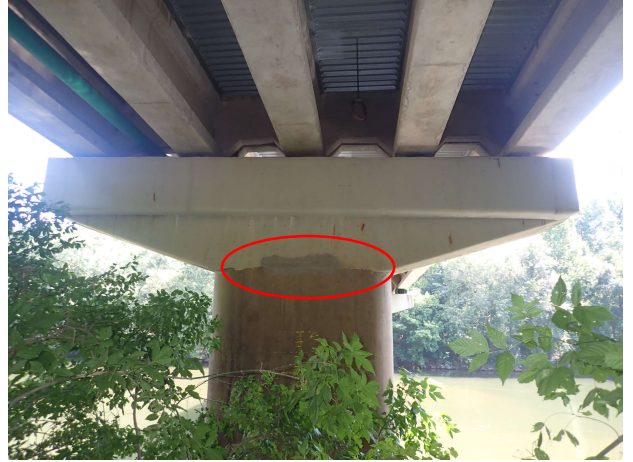
Underside of Bridge at Bent 2 Rear

Stay in place metal forms are apparent in between beams. Epoxy repair in the pier is in good condition.

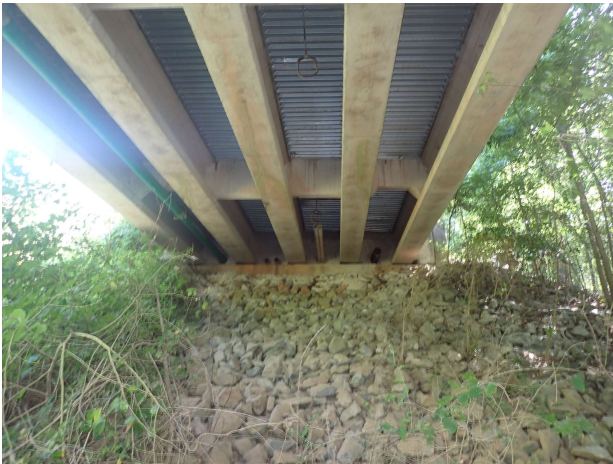
Bent 6 Rear

Concrete was pumped around and under cap to cover exposed piles in the past. Repair is in good condition. Rip rap protection is in good condition.
